INTERSTATE COMMERCE COMMISSION

REPORT OF THE DIRECTOR OF THE BUREAU OF SAFETY IN RE INVESTIGATION OF AN ACCIDENT WHICH OCCURRED ON THE CHICAGO, INDIANAPOLIS & LOUISVILLE RAILWAY AT GUERNSEY, IND., ON MARCH 19, 1931.

May 4, 1931.

Inv. No. 1697
 Chicago, Indianapolis & Louisville Ry.
 Guernsey, Indiana
 March 19, 1931

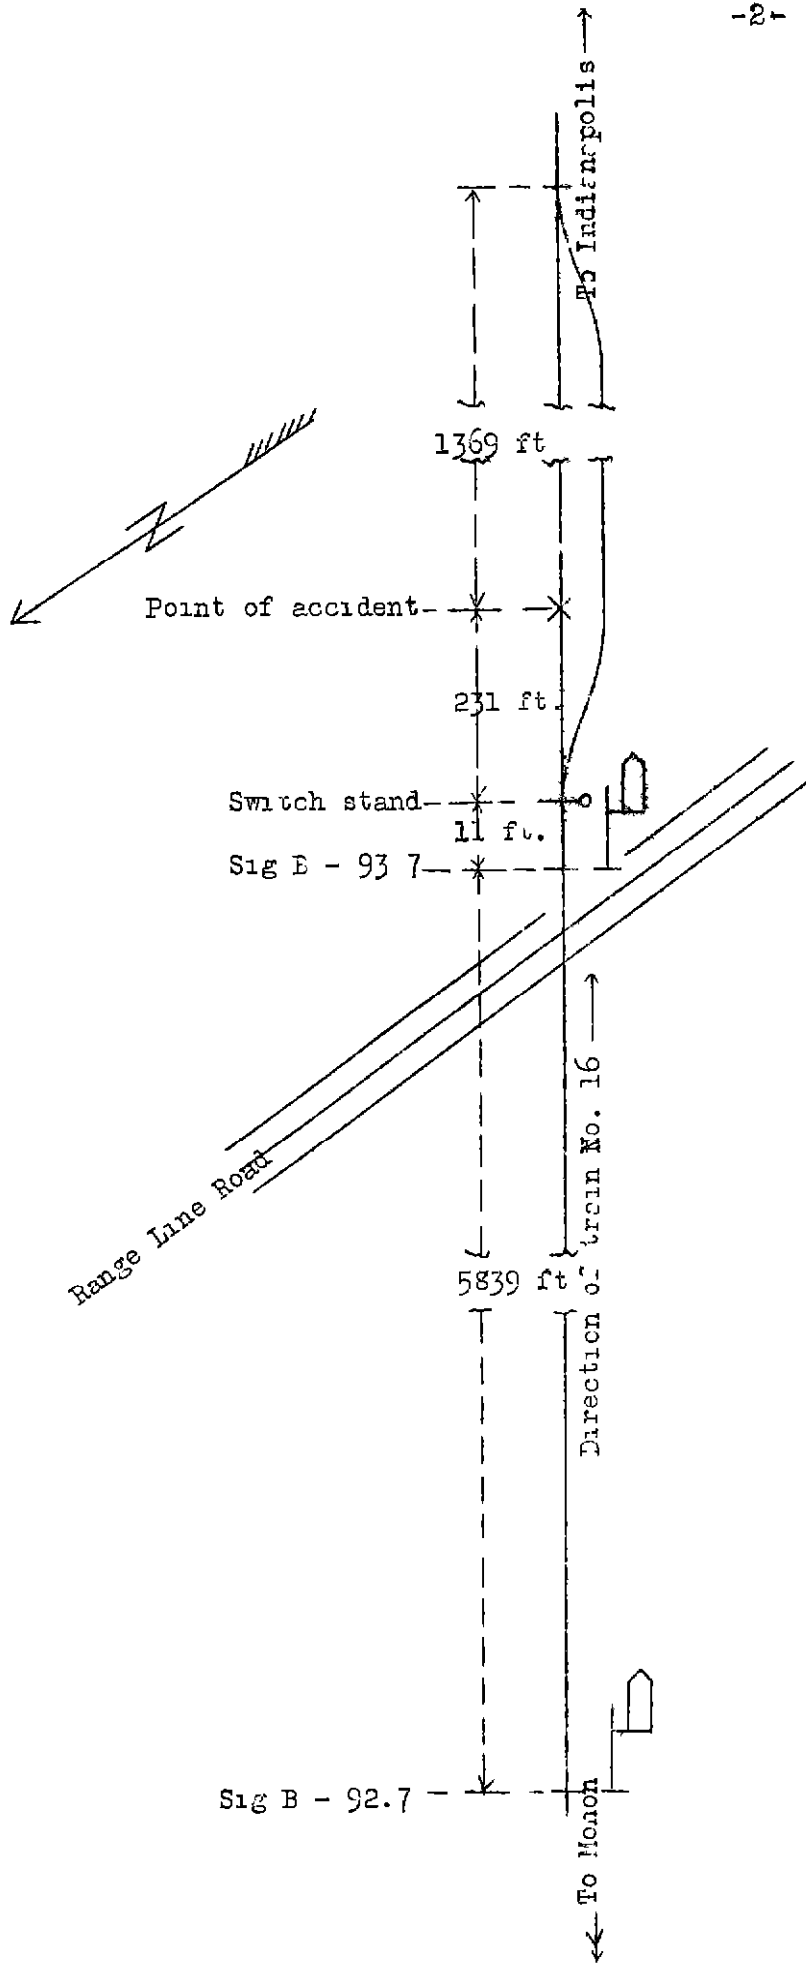
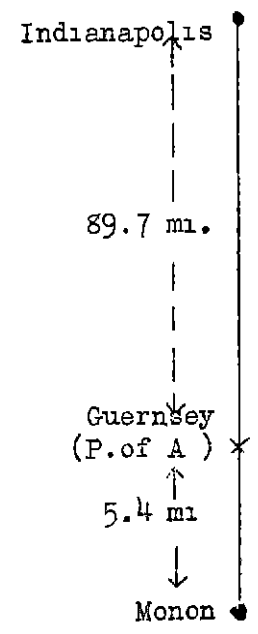
The passing track at Guernsey is 1,600 feet in length and parallels the main track on the west. The switchstand of the north switch is located on the engine-man's side of a southbound engine, the switch lamp being about 8 feet above the ties; a green indication is displayed by the lamp when the switch is lined for the main track, as was the case in this instance. Southbound automatic block signals B-93.7 and B-92.7, the signals involved, are of the three-position, upper-quadrant type, and are located 11 feet and 5,850 feet, respectively north of the north switch of the passing track; night indications are red, yellow, and green, for stop, caution, and proceed

Sig B - 92.7
