## INTERSTATE COMMERCE COMMISSION

REPORT OF THE DIRECTOR OF THE BUREAU OF SAFETY CONCERNING  
INVESTIGATION OF AN ACCIDENT WHICH OCCURRED ON THE  
CHICAGO, INDIANAPOLIS & LOUISVILLE RAILWAY AT  
INDIANAPOLIS, IND., ON MARCH 2, 1932.

April 7, 1932.

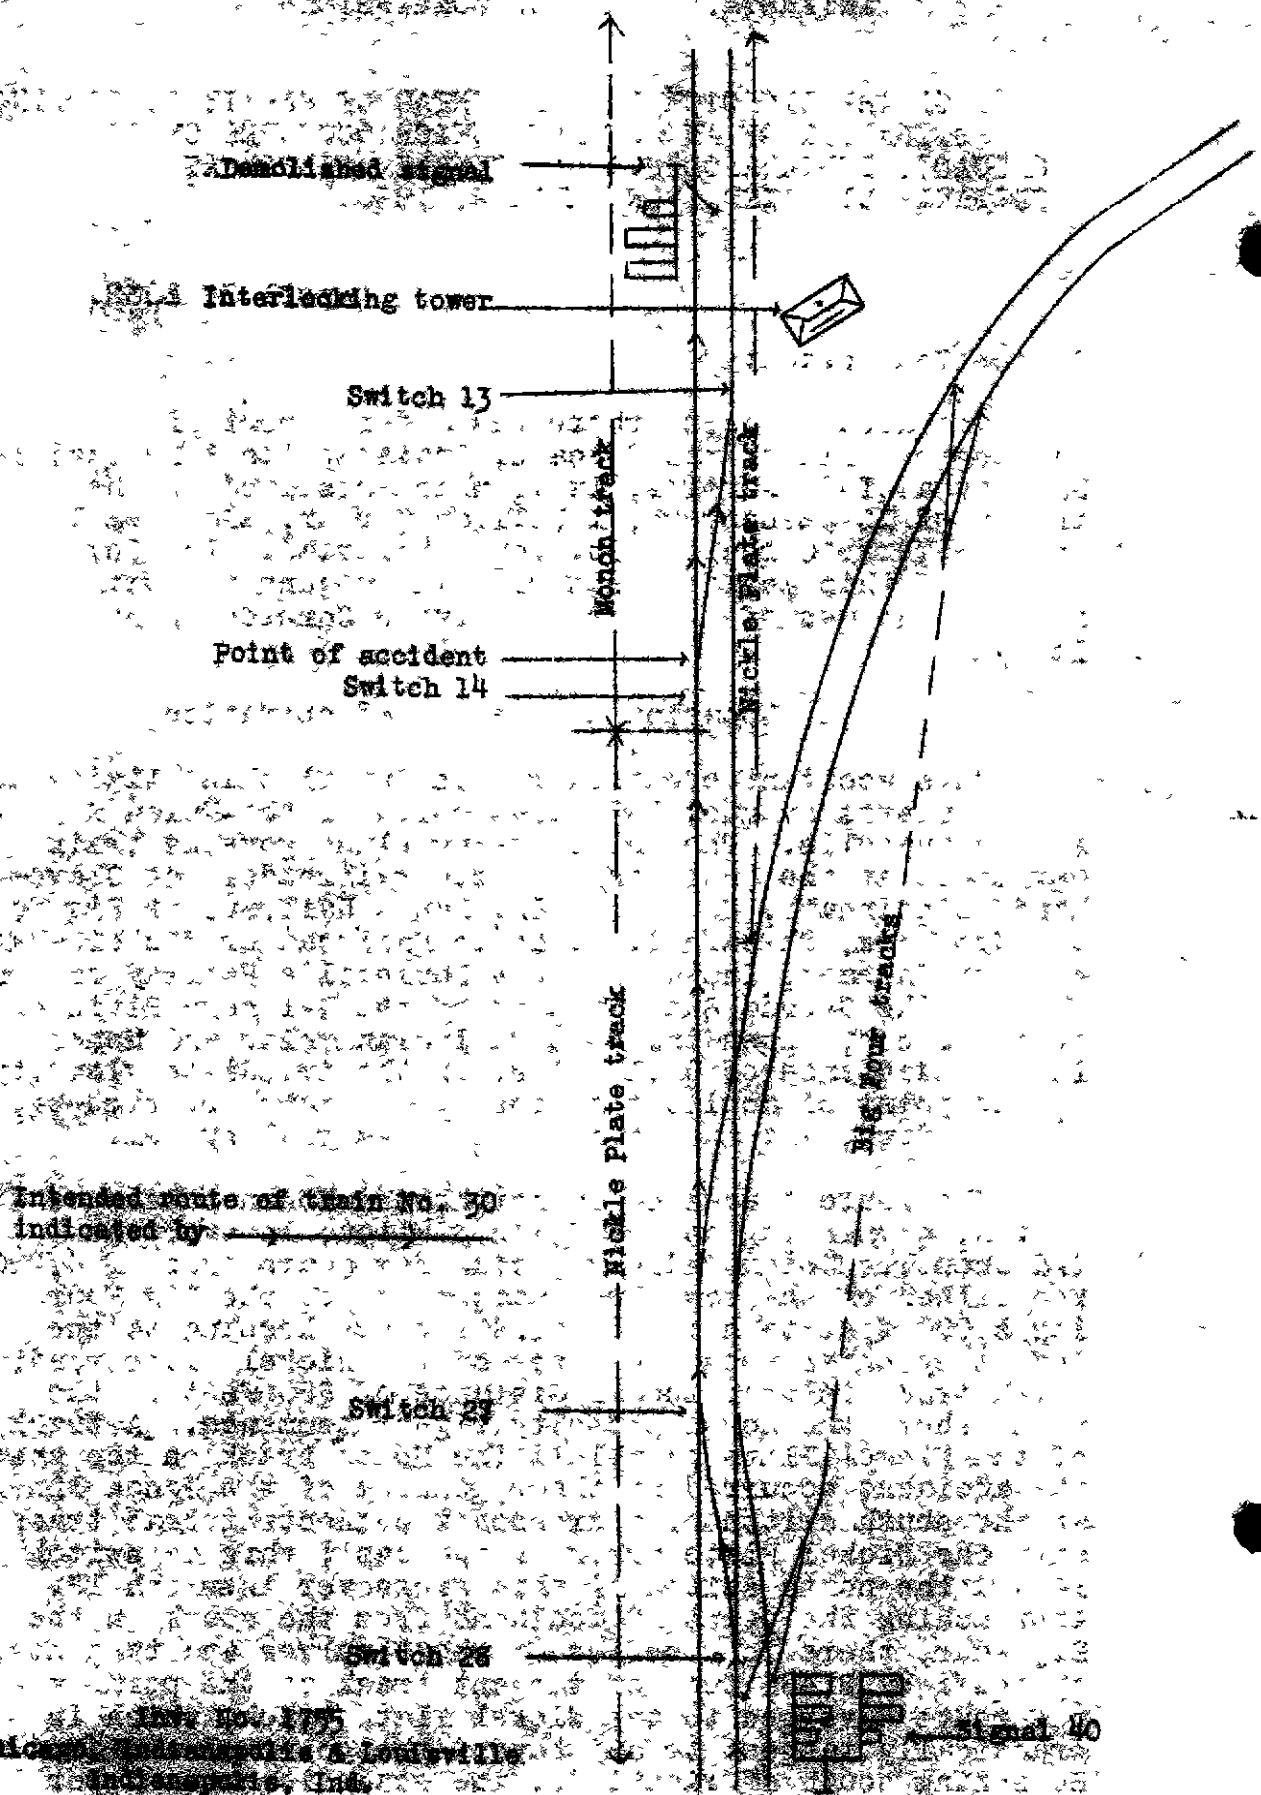
Chicago & Louisville  
March 2, 1932

Point of accident  
Switch 14

This accident was caused by a switch being opened under the sixth car of train No. 30 within interlocking limits; a contributing cause was the fact that the detector bar which should have prevented the operation of this switch under a moving train failed to perform its intended function, due to improper maintenance.

Inspection and tests clearly showed that the detector bar at the switch involved, which was intended to prevent the operation of the switch under a moving train, failed to function. There was lost motion between the switch machine and the bar, the bar was  $\frac{1}{4}$  inch lower than it should have been, and the result was that it was possible to move the switch points under a train without the detector bar preventing such action. The condition of this detector bar and its application to the rail was such that it was not reliable to prevent the very kind of an accident for which it was installed. This condition was one which adequate inspection and maintenance should have corrected. At other switches in this plant detector bars had been replaced by detector circuits, because of the greater reliability of such circuits as a means of protection against accidents of this character. It is believed that consideration should be given to the need for detector locking at all switches in this plant which are not now so equipped.
